## **Curing a Leaking Swivel**

Your new Liberty® Hose Reel or hose reel cart is leaking at the swivel.

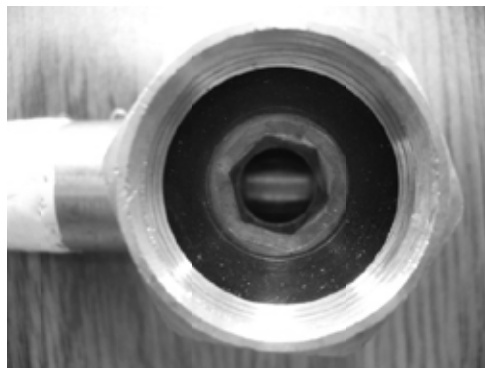
It is normal for the swivel to leak slightly until the O-rings (they are located on the inside of the swivel) are wet and seated. If the leaking continues, you do not need to take the cart back to the store. This is a simple problem and is easily fixed by a simple procedure.

1. If the leader hose is attached to the swivel, unscrew the hose and look inside the swivel.
2. Using either a hex key or a large screwdriver, insert the tool into the hex opening and gently tighten the threaded insert. **DO NOT OVER TIGHTEN!**
3. This should stop the leaking.
4. If the unit leaks, please check that the hose washer is inside the nut.  
You may contact Liberty for a new hose washer or obtain one at any hardware store.
5. If your swivel is old, the O-rings may be worn, please contact us for a new set of o-rings.
6. If these steps do not solve your leaking problem, then contact Liberty Garden.
